W3F1-2005-0070

Subject: Licensee Event Report 2005-004-00  
Waterford 3 SES  
Docket No. 50-382  
License No. NPF-38

4. TITLE Loss of Offsite Power During Hurricane Katrina
--

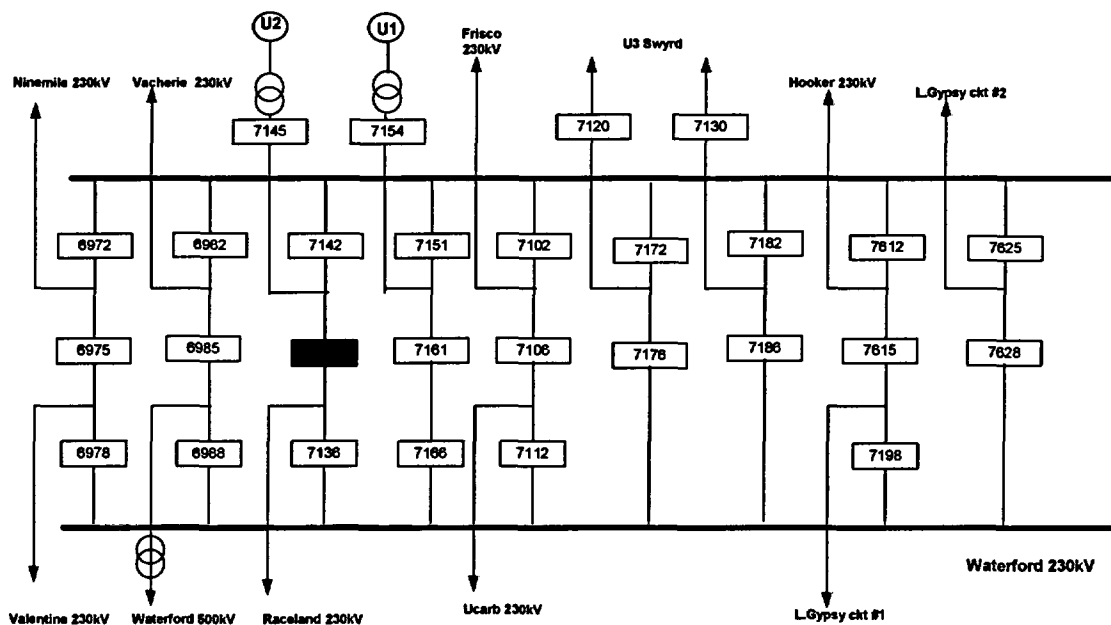
**FIGURE 1**  
Waterford 3 Switchyard Arrangement

The arrangement of the Waterford 3 switchyard [FK] is presented in Figure 1. The physical configuration of the Waterford 3 Switchyard (SWYD) and Switching Station (SWSTA) is designed to minimize degraded switchyard conditions. The Waterford 3 SWYD uses a breaker and half scheme with East and West busses. Waterford 3 is connected to the utility grid by two transmission lines [FK] to the Waterford 3 - 230 kV Switchyard via the Switching Station [FK]. Each line is designed to carry the full load required for safe shutdown of the plant. Each line can carry 100% output of the main generator. Transmission lines to the Waterford 3 SWSTA from the SWYD are each tied to the busses by one dedicated breaker (double bus double breaker scheme). These two 230 kV transmission lines, along with the 6.9 kV busses and bays connecting the Waterford 3 - 230 kV SWYD with the Waterford 3 SWSTA, are addressed in Waterford 3 TS 3.8.1.1 Limiting Condition for Operation (LCO) as the two physically independent circuits between the offsite transmission network and the onsite Class 1E distribution system that are required operable in Modes 1, 2, 3, and 4.

The Waterford 3 - 230 kV Switchyard also has several other 230 kV transmission lines connected to it. Three of these transmission lines connect Waterford Units 1 and 2 to the Switchyard. Three of the transmission lines cross the river on two separate river crossing towers to tie into the Little Gypsy 230 kV Switchyard. There is a 230kV tie to the adjacent 500kV Switchyard. There are other transmission lines which tie to other areas of the Entergy grid. The system is designed such that no transmission lines cross the 230kV lines connecting the Waterford 3 switching station to the Waterford 3 230kV Switchyard. A single failure such as spurious protective relay operation, breaker failure or transmission line failure associated with the offsite power source will be limited to one train of offsite power only.
